TECHNICAL REPORT

Accident occurred on September 13th, 1982,
to McDonnell Douglas DC-10-30-CF aircraft, reg. n. EC-DEG,
at Malaga Airport.

SYNOPSIS

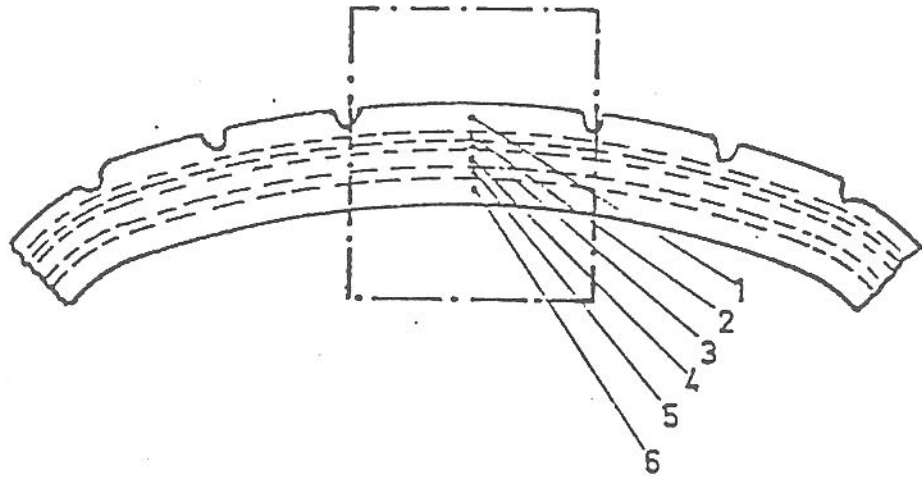
FIG.- 1.

In order to perform a detailed description of the visual inspection of the pieces of tire received, Figure 1 includes a representation of the layers observed so as to simplify the description of the faults found.

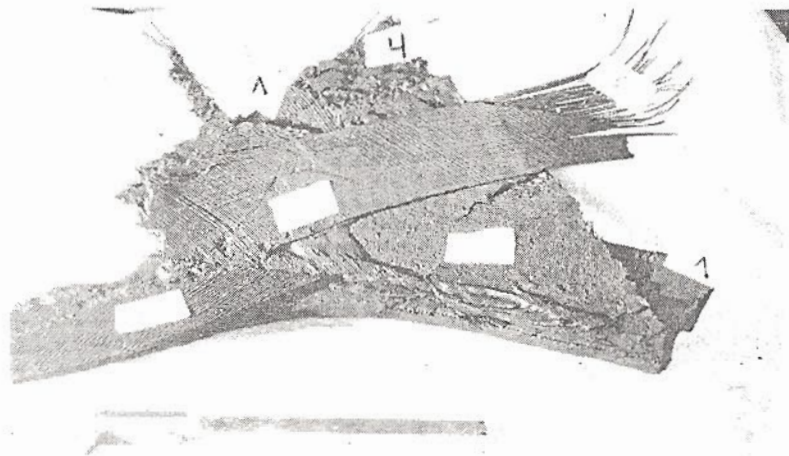
weaving was only found in two relatively small pieces. In both cases, it appears as a 5 cm. wide layer, and the direction of the threads does not match with any other layer of weaving (photographs 3 and 4), i.e., this layer 3 does not follow the alternating direction beginning in the other two, which would be the normal thing, as the aforementioned fig. 1-1 from T.O.-45-1-3, shows.

* It must be pointed out that the third layer does not cover the whole of the retreaded surface, while the other two layers do seem to cover it. The only two pieces in which the said third layer appears figure in photographs 3 and 4; after observation of the piece in photograph 4 it cannot be asserted that the said 3rd layer of weaving does not cover the whole of the surface, since the prints found on the intermediate rubber strip, beside the 3rd layer of weaving, follow the direction of the weaving and it can be admitted that the said layer was stuck to them. In return, piece 4-5, in photograph 3, shows some prints on this third layer which seem to correspond to the carcass itself and that continue on the intermediate rubber strip (position 4 of figure 1), similar to the ones appearing on the intermediate rubber strip in photograph 12, piece 1, and photograph 13, piece 3, in which this third layer does not exist. Precisely these pieces in photographs 12 and 13, show how the intermediate rubber strip comes to the sidewall, which enables to state that the said intermediate strip was installed in the last retread.

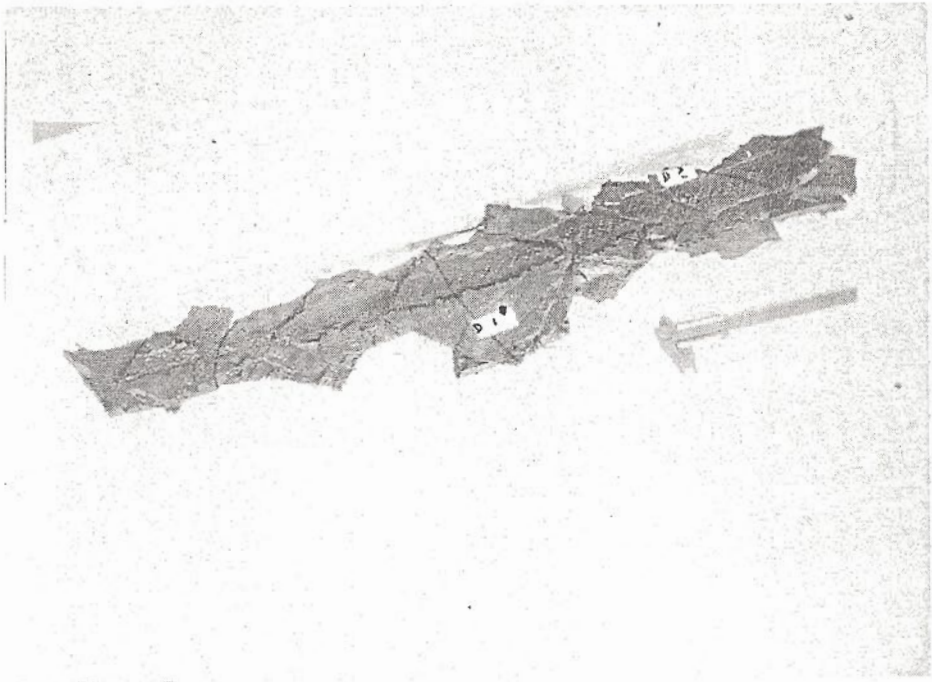
Tearing of the intermediate rubber strip, presenting an alveolar surface, surrounded by a spongy zone. Photograph n. 7 and details in n. 8, 9, and 10. It could be considered as a variant of type 4. This type of breakage is found in a not very large zone, below the central zone of the tread of tire.

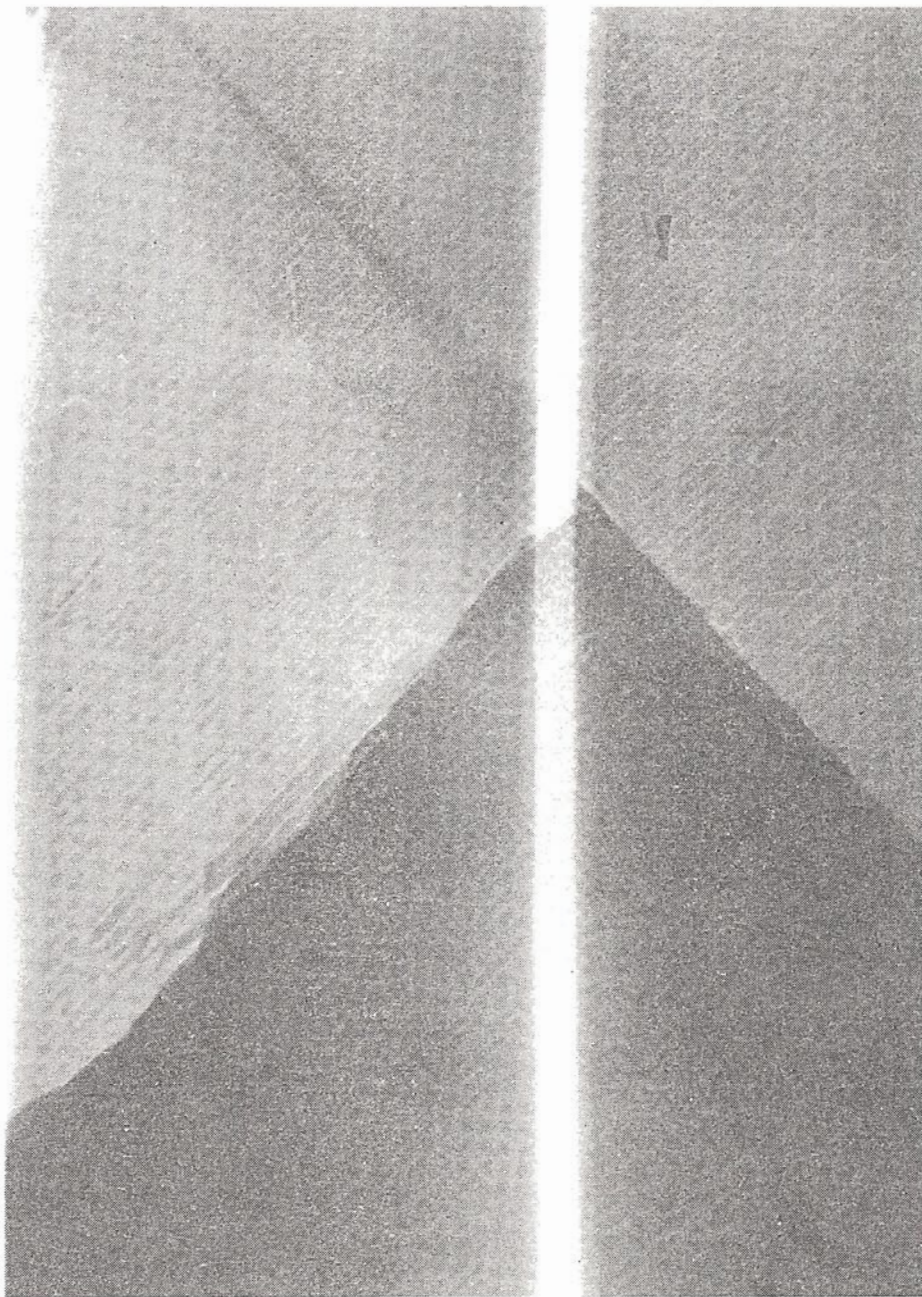
11

A radiograph was made of this zone (photograph n. 11) in order to detect, if any, holes of the type described in the above paragraph. No cavity was found, which
