TECHNICAL REPORT

Accident occurred on September 13th, 1982,
to McDonnell Douglas DC-10-30-CF aircraft, reg. n. EC-DEG,
at Malaga Airport.

SYNOPSIS

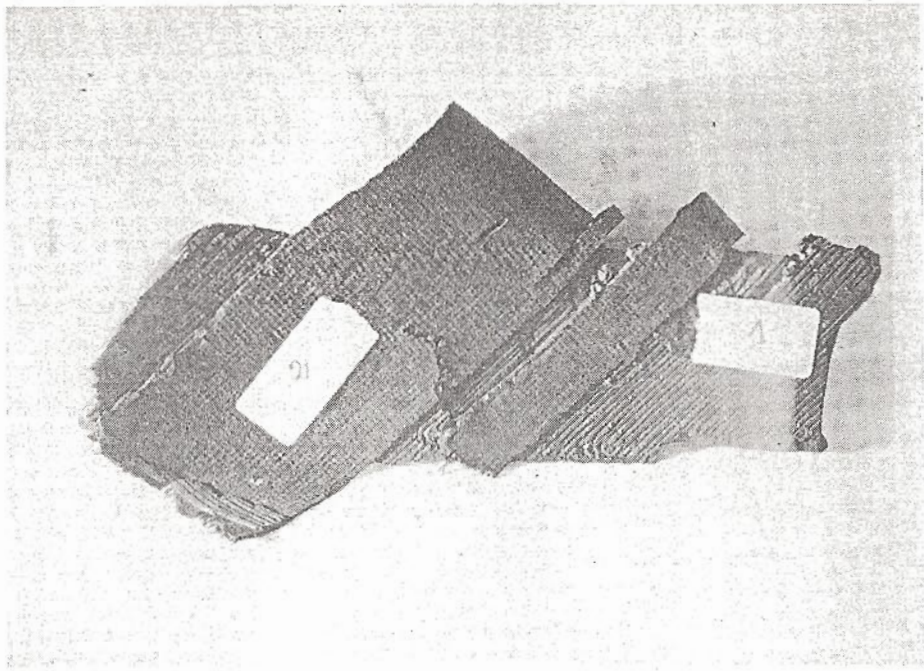
Unsticking between the tread of tire rubber and 1st. layer of the weaving (photographs 1 and 5).

Unsticking between 1st. and 2nd. layers of the weaving (photographs 1 and 6).

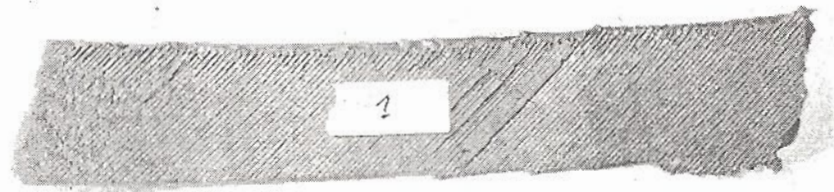
* It must be pointed out that the third layer does not cover the whole of the retreaded surface, while the other two layers do seem to cover it. The only two pieces in which the said third layer appears figure in photographs 3 and 4; after observation of the piece in photograph 4 it cannot be asserted that the said 3rd layer of weaving does not cover the whole of the surface, since the prints found on the intermediate rubber strip, beside the 3rd layer of weaving, follow the direction of the weaving and it can be admitted that the said layer was stuck to them. In return, piece 4-5, in photograph 3, shows some prints on this third layer which seem to correspond to the carcass itself and that continue on the intermediate rubber strip (position 4 of figure 1), similar to the ones appearing on the intermediate rubber strip in photograph 12, piece 1, and photograph 13, piece 3, in which this third layer does not exist. Precisely these pieces in photographs 12 and 13, show how the intermediate rubber strip comes to the sidewall, which enables to state that the said intermediate strip was installed in the last retread.

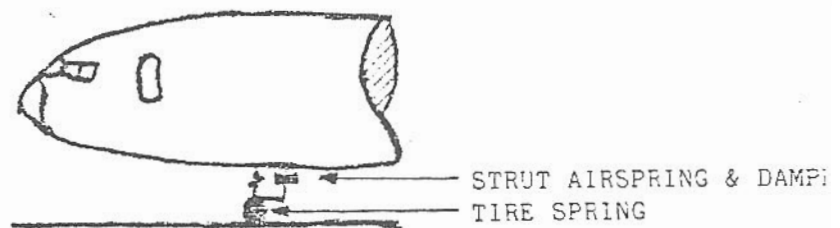
The theoretical conditions established for this study are the following:

- strut airspring = 8258 lb./inch for half airplane.
- strut damper force = $C_s X^2 = C_L X$
- C_s = Damper coefficient = 37.5 LB/(IN/SEC)² (half airplane).
- X = Velocity of tire relative to cockpit (IN/SEC)
- C_L = Linear approximation for damper
- $C_L = \frac{8WX_0}{3\pi} C_s$ (Frequency and amplitude dependent)
- W = Frequency (RAD/SEC)
- X_0 = Amplitude (IN)
- Tire spring = 10,000 lb/in for half airplane.
- Tire imbalance force = $m r w^2$
- m = mass imbalance
- r = Tire radius = 18 in.

NOTE: Results in vertical and longitudinal forces 90 degrees out of phase.
